UIC Code

7 1 2

4th edition, January 2002

Rail defects

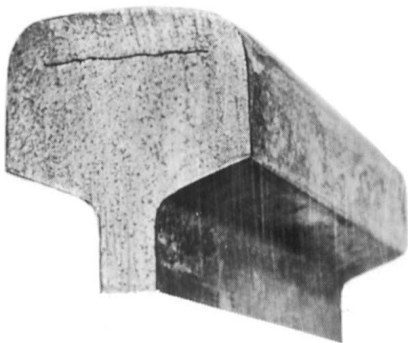
112 HORIZONTAL CRACKING

Manufacturing defect.

The horizontal cracking is characterised by the gradual separation of the upper part of the rail head (see - 112 (fig. 1) - page 17).

It starts inside of the rail head and progresses parallel to the running surface. A small crack appears on one or both faces of the head and on the end face in the gap of the expansion joint. It is sometimes accompanied by a vertical crack (see - 112 (fig. 2) - page 17). Not to be confused with 113 - page 18.

This crack may be combined with crushing of the rail end and a widening of the running surface is generally observed.

- keep cracked rail under inspection,
- remove the rail,
- immediate removal of the broken rail.

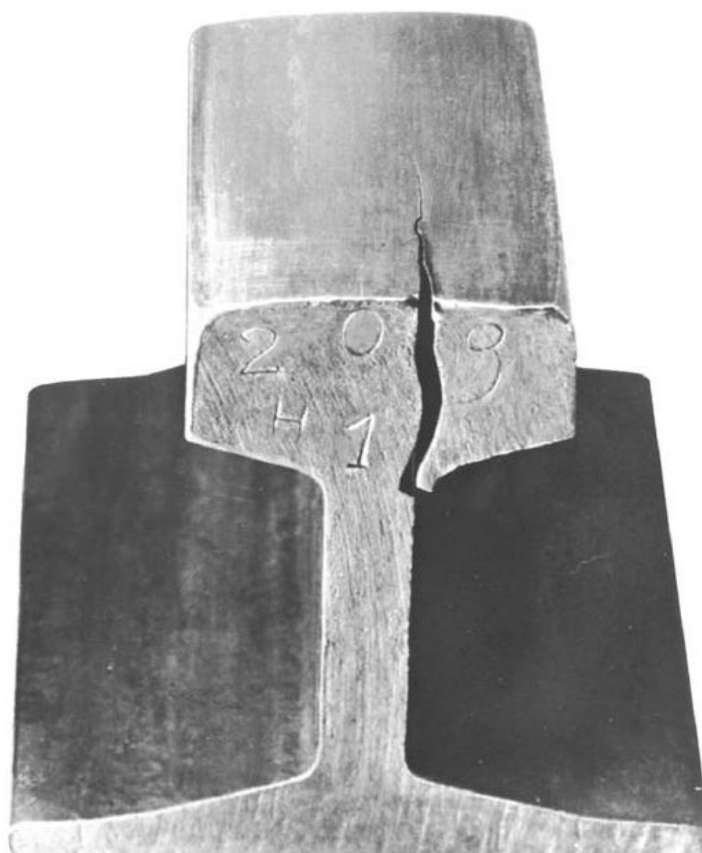
113 LONGITUDINAL VERTICAL CRACKING

Manufacturing defect.

This crack tends to divide the head gradually into two parts, following a plane parallel to the rail web (see - 213 - page 43).

When the defect reaches the running surface, it is identifiable by a black line on this surface. A depression of the running surface can then be observed as well as a widening of the head corresponding to the opening of the crack.

- immediate removal of the rail.

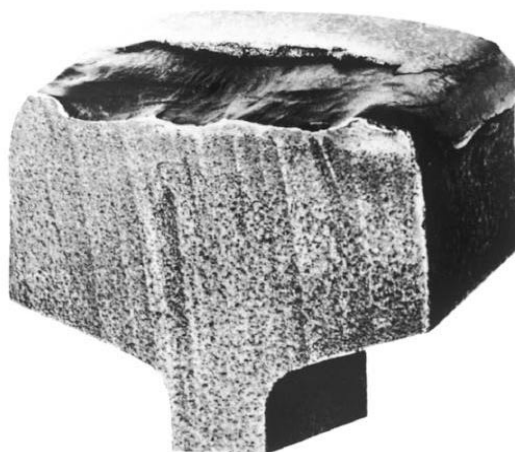
122

Defect due to traffic loads.

- repair by resurfacing,
- removal of the rail.

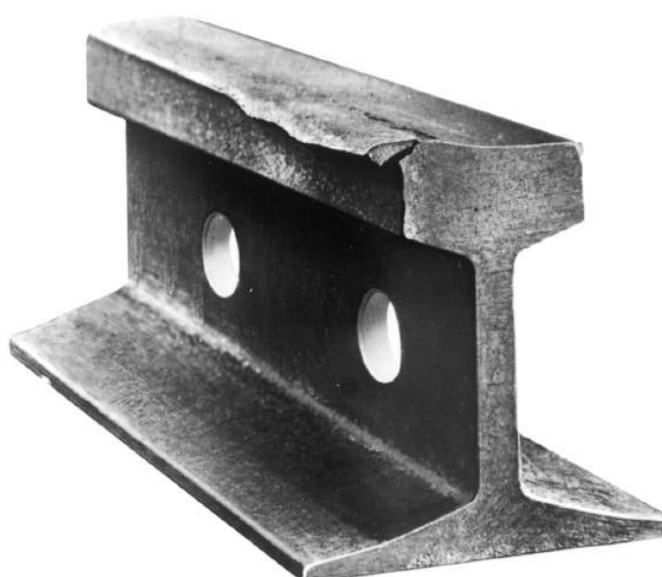
123

Defect due to traffic loads.

- keep rail under inspection,
- grind the lips if necessary,
- repair by resurfacing.
